Technical Memorandum

Prepared for: City of Pittsburg
Project Title: Water Filter Rehabilitation
Project No.: 146044

Subject: Filter Gallery Piping Evaluation
Date: June 18, 2015
To: Walter C. Pease, Director of Water Utilities
From: William K. Faisst, Ph.D., P.E., Vice President
Copy to: Jason Moser, Chief Operator

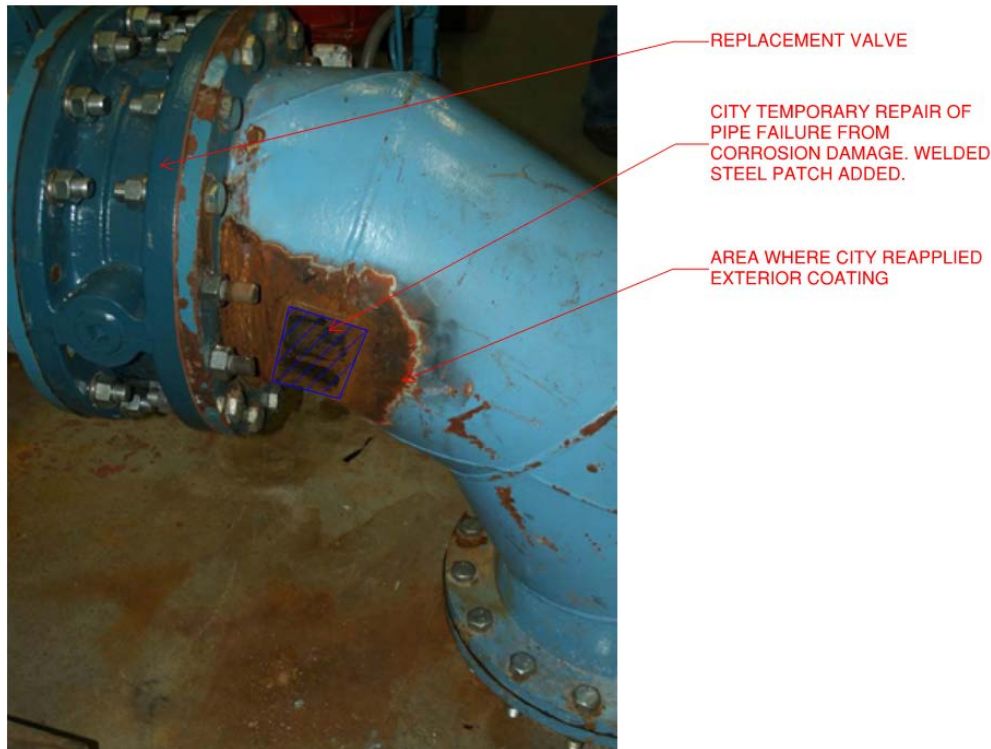
Figure 1-1. Repaired Filter 7 Backwash Inlet Elbow

In 2009, the City of Pittsburg (City) Water Treatment Plant (WTP) experienced a pipe failure within the WTP Filter Gallery for Filter 7. City staff repaired the pipe and owing to the valve’s age and deteriorating condition, also replaced the adjacent 16-inch butterfly valve. The failure raised questions about the condition of the filter piping, fittings, valves and appurtenances of other filters. Figure 1-1 shows the recent spot repair and replacement valve at the Filter 7 backwash elbow.

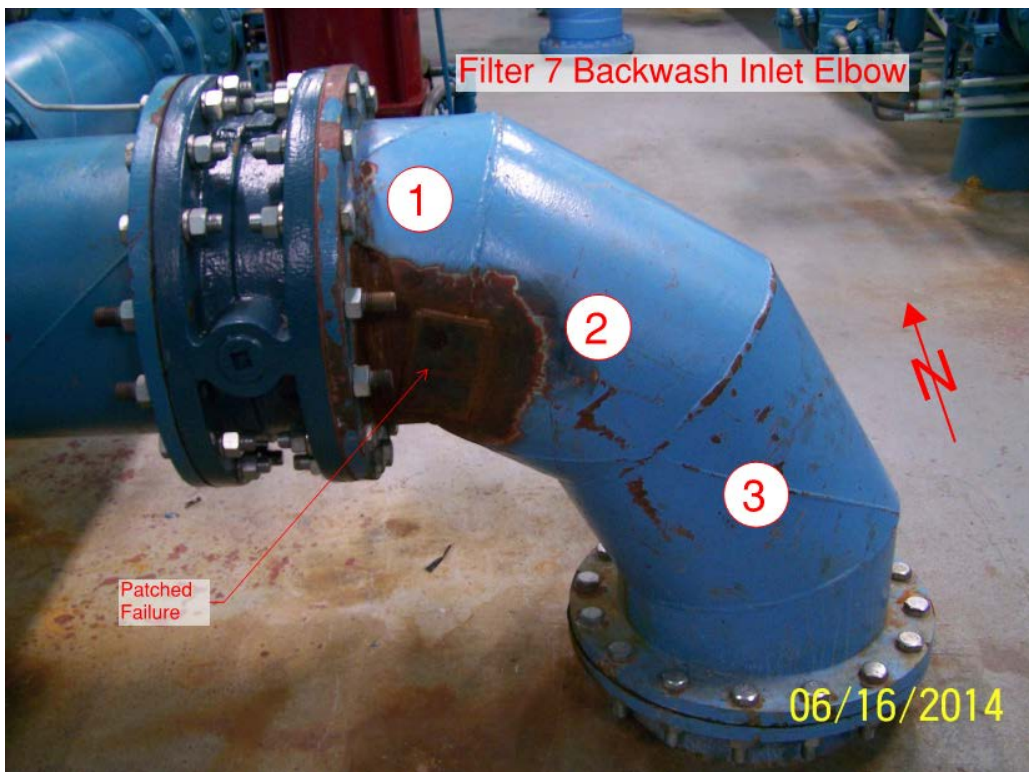
Figure 2-1. Filter 7 Backwash Inlet Elbow Measurement Locations

Figure 2-1 shows the thickness testing locations listed in Table 2-1.

Location	Top	South	Bottom	North
1	0.178	0.122	0.143	0.156
2	0.176	0.152	0.150	0.154
3	0.171	0.153	0.150	0.150

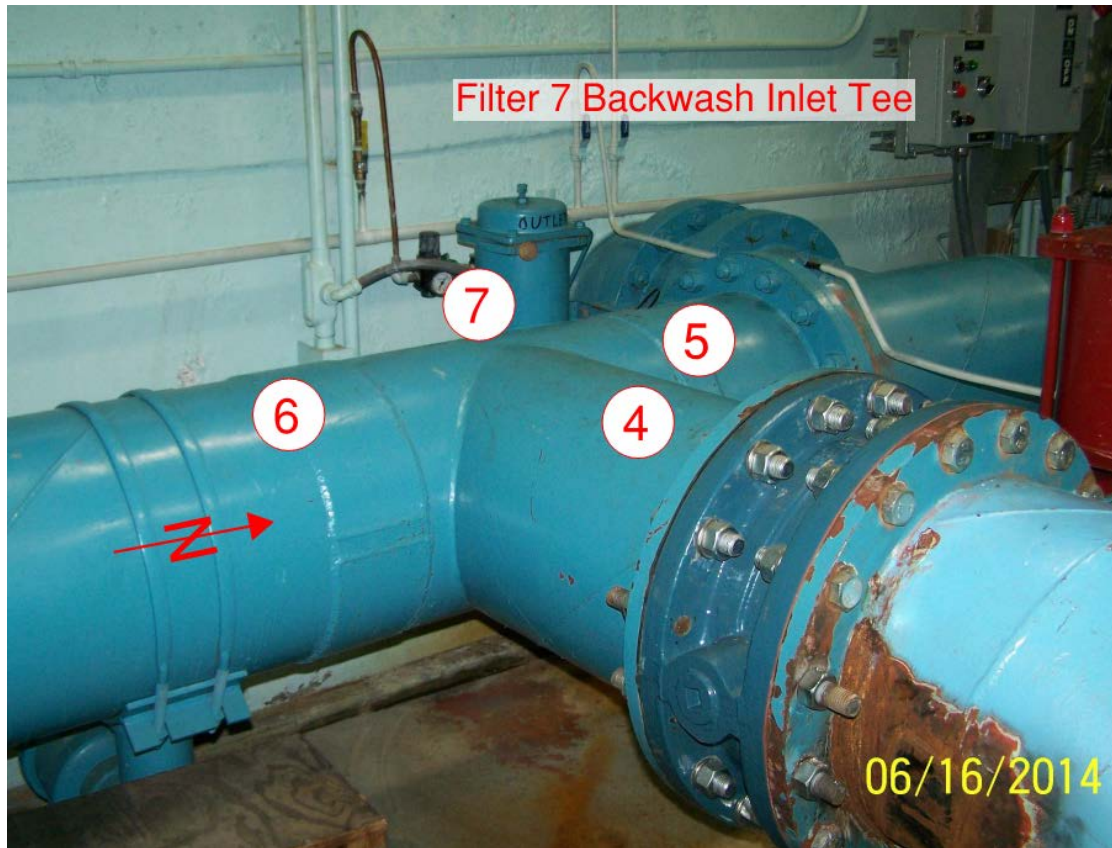
Figure 2-2. Filter 7 Backwash Inlet Tee Measurement Locations

Figure 2-2 shows the thickness testing locations listed in Table 2-2.

Table 2-2. Field Measurement of Filter 7 Backwash Inlet Tee Thicknesses (inches)				
Location	Top	South	Bottom	North
4	0.154	0.156	0.144	0.150
Location	Top	West	Bottom	East
5	0.174	0.154	0.176	0.150
6	0.148	0.146	0.150	0.152
7	0.157	0.161	0.150	-

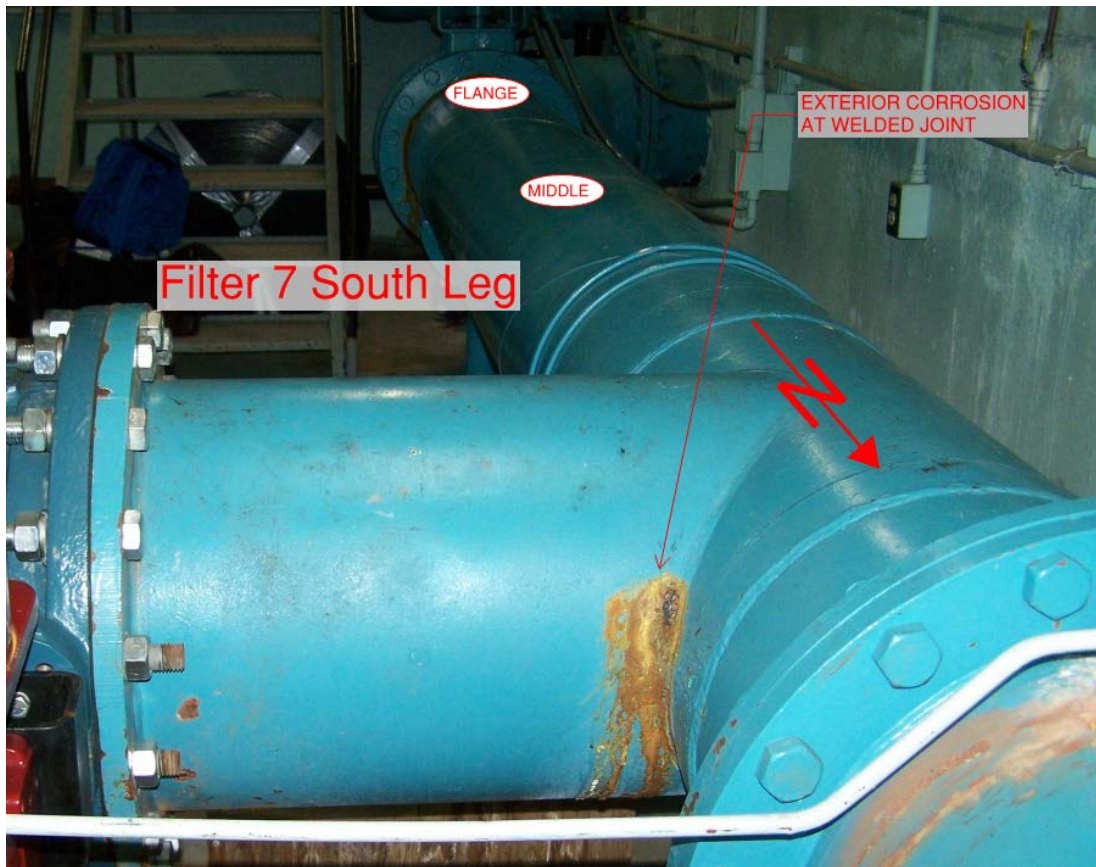
Figure 2-3. Filter 7 South Leg Measurement Locations

Figure 2-3 shows the thickness testing locations listed in Table 2-3.

Table 2-3. Field Measurement of Filter 7 South Leg Thicknesses (inches)				
Location	Top	West	Bottom	East
Middle	0.151	0.144	0.150	0.143
6 inches North of Flange	0.164	0.145	0.148	0.148

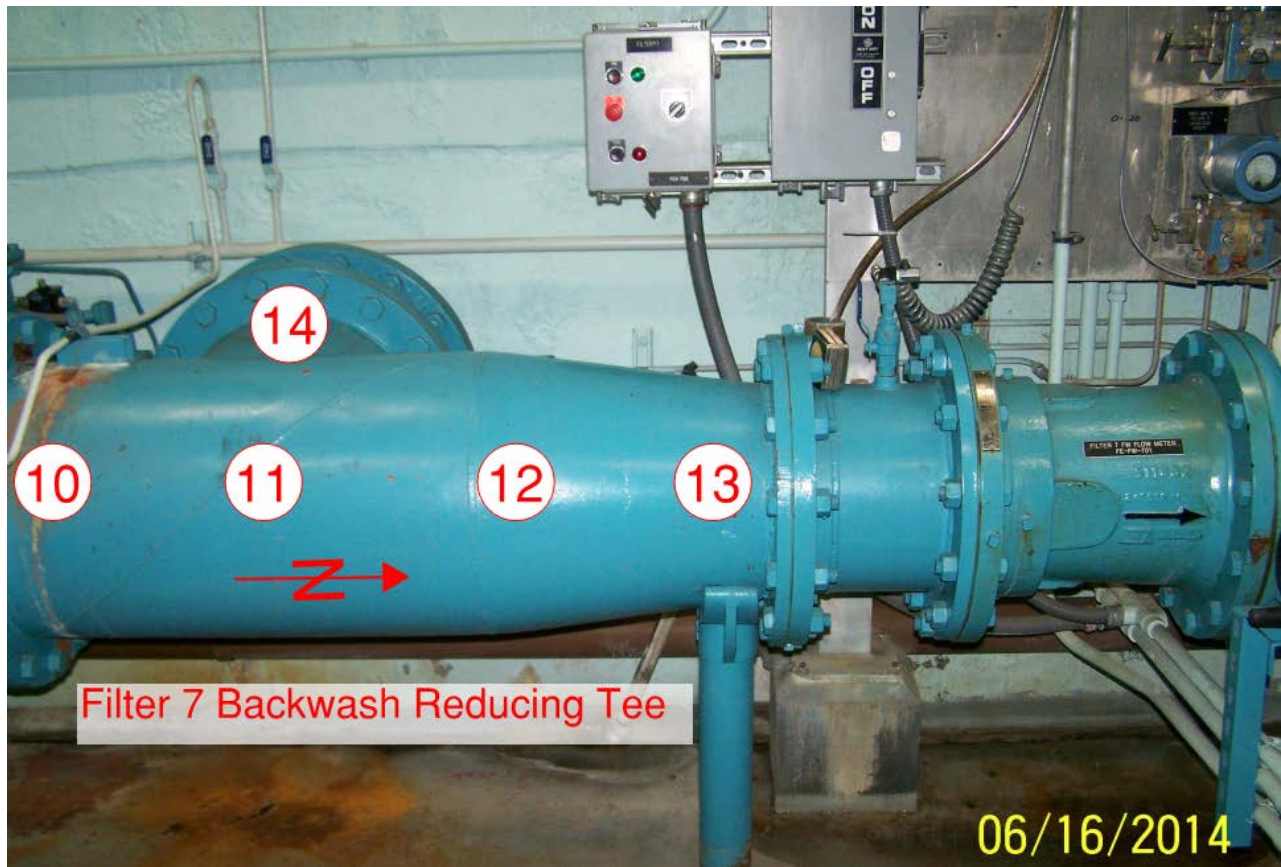
Figure 2-4. Filter 7 Backwash Reducing Tee Measurement Locations

Figure 2-4 shows the thickness testing locations listed in Table 2-4.

Table 2-4. Field Measurement of Filter 7 Backwash Reducing Tee Thicknesses (inches)				
Location	Top	West	Bottom	East
10	0.126	0.116	0.136	0.118
11	0.130	NA	0.130	0.114
12	0.114	0.112	0.115	0.111
13	0.112	0.117	0.110	0.114
14	0.126	0.135 (South)	0.133	-

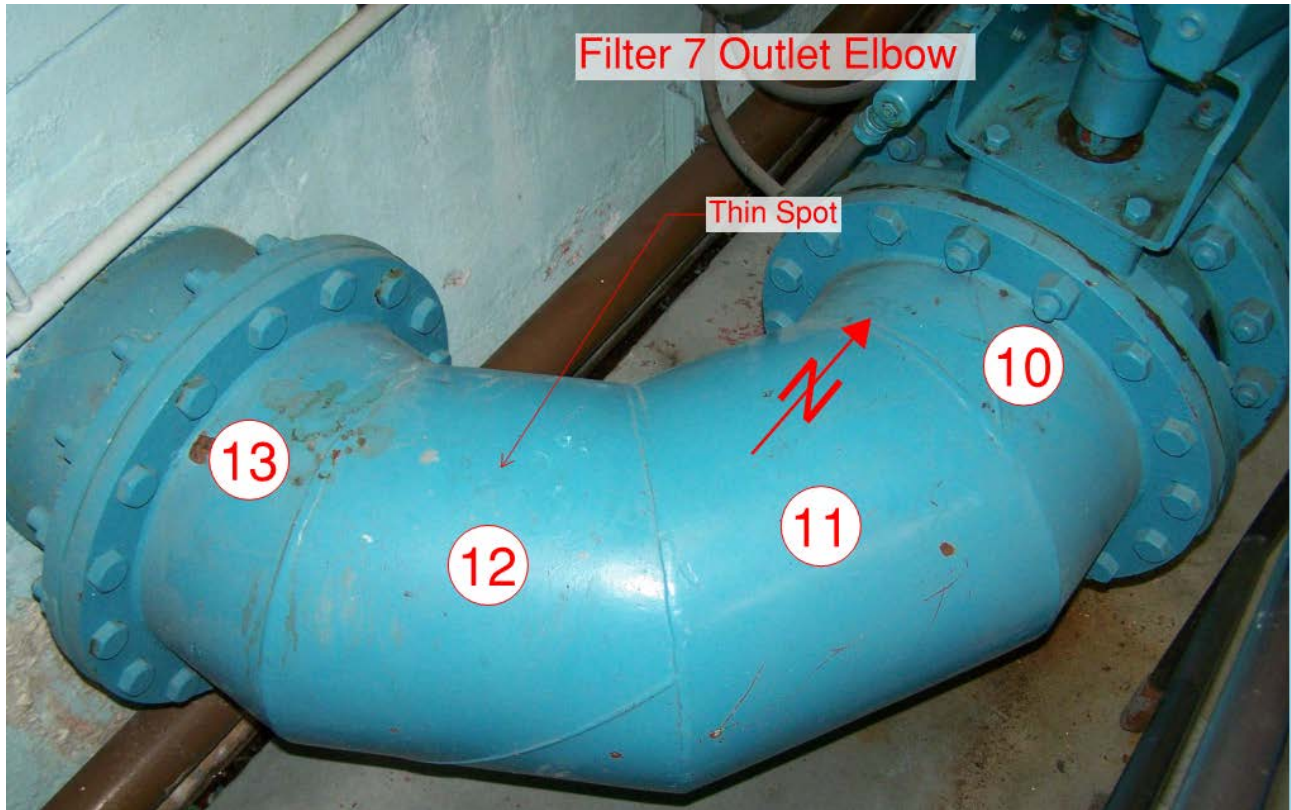
Figure 2-5. Filter 7 Outlet Elbow Measurement Locations

Figure 2-5 shows the thickness testing locations listed in Table 2-5.

Table 2-5. Field Measurement of Filter 7 Outlet Elbow Thicknesses (inches)				
Location	Top	West	Bottom	East
10	0.163	-	-	-
11	0.164	-	0.143	-
12	0.064	0.169	0.171	0.154
13	0.168	0.150	-	0.150

Through testing the Filter 7 inlet and outlet piping, one severely thin spot was discovered on top of the outlet elbow (Location 12). Up to about 70 percent of the pipe thickness was lost (assuming that the original pipe wall thickness was approximately 0.19 inches). In addition to the thin spot, several locations with significant external corrosion were also observed.

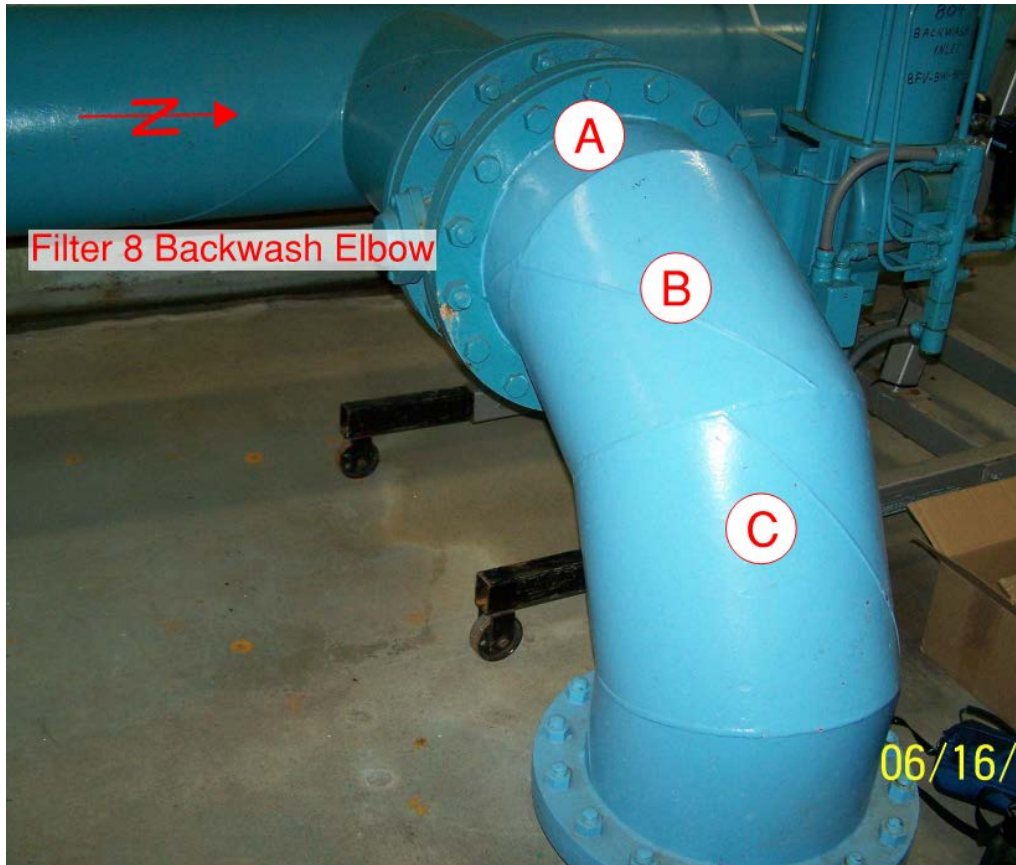
Figure 2-6. Filter 8 Backwash Elbow Measurement Locations

Figure 2-6 shows the thickness testing locations listed in Table 2-6.

Table 2-6. Field Measurement of Filter 8 Backwash Elbow Thicknesses (inches)		
Top	A	0.172
	B	0.187
	C	0.178

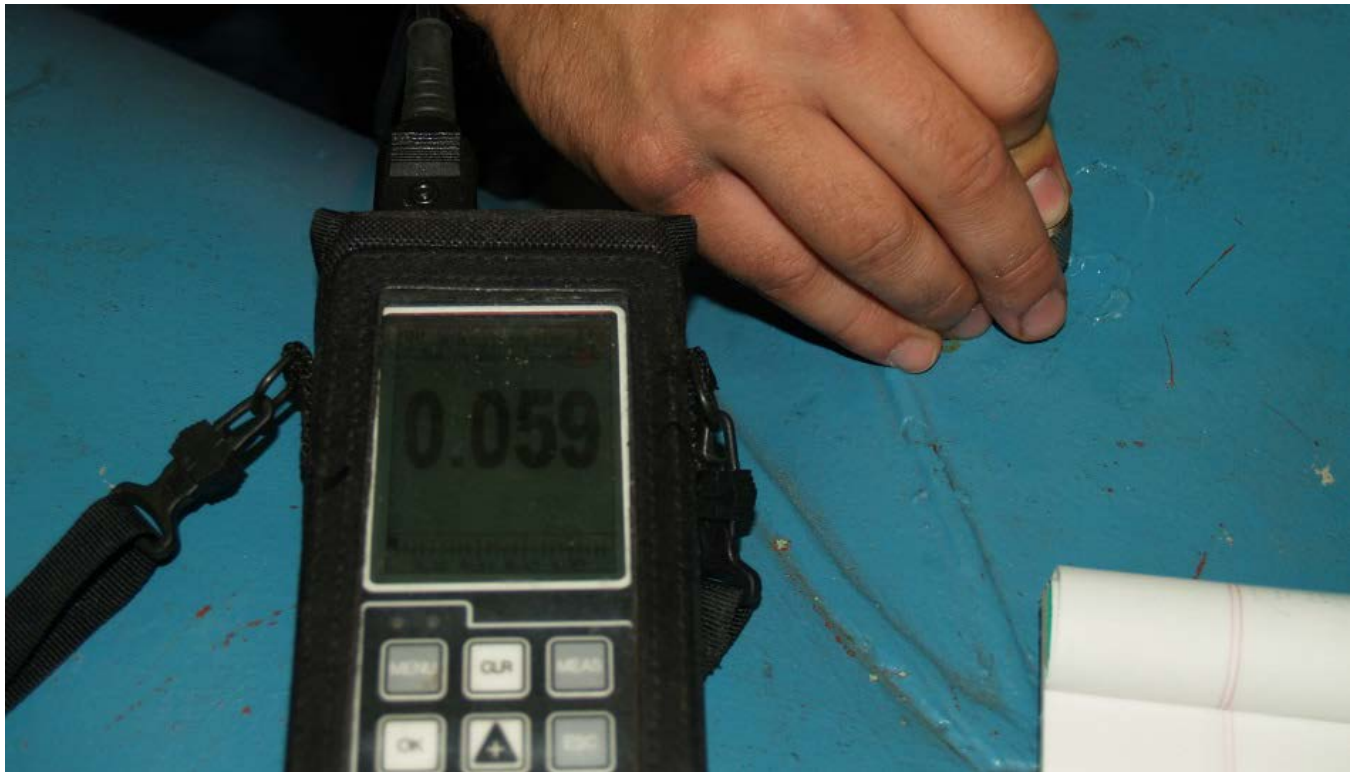
Figure 2-7. Filter 8 Outlet Tee with Ultrasonic Thickness Gage

Figure 2-7 shows the ultrasonic thickness gauge used to perform the testing. The gauge display indicates a thin spot discovered 4 inches from the flange of the Filter 8 outlet tee (see Table 2-7).

Table 2-7. Field Measurement of Filter 8 Outlet Tee Thicknesses (inches)		
Top	0.102	0.105
	0.106	0.114
	0.066/0.059/0.067 (thin spot 4 inches from flange)

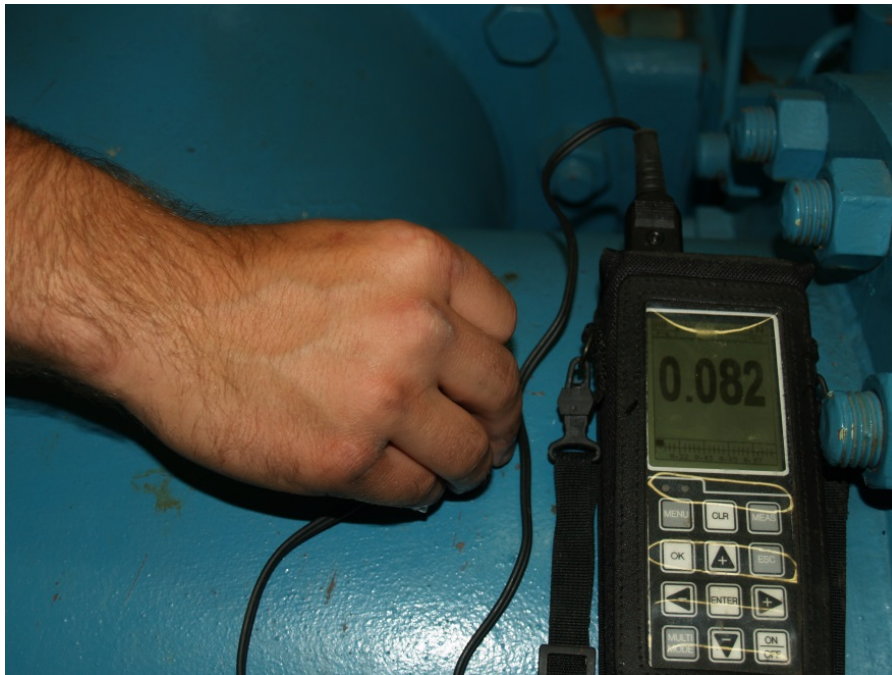
Thin spots were measured on the filter piping at the crowns of the elbow and tee, as shown on Figures 2-8A and 2-8B and listed in Table 2-8.

Figure 2-8A. Ultrasonic Thickness Tester at Thin Spot at Filter 8 Tee
(Location with a measured thickness of less the 0.10 inches)

Table 2-8. Field Measurement of Filter 8 Outlet and Inlet Piping Thicknesses (inches)				
Filter 8: Backwash Inlet Tee (Top)				
Top	0.129	0.098	0.175	
Filter 8: Reducer				
Top	0.125/ 0.103/0.082			
West	0.107/ 0.117/ 0.108/ 0.105			
East	0.098/ 0.107/ 0.105/ 0.107			
Filter 8: Outlet Elbow Top				
Top	0.095	0.159	0.166	0.062

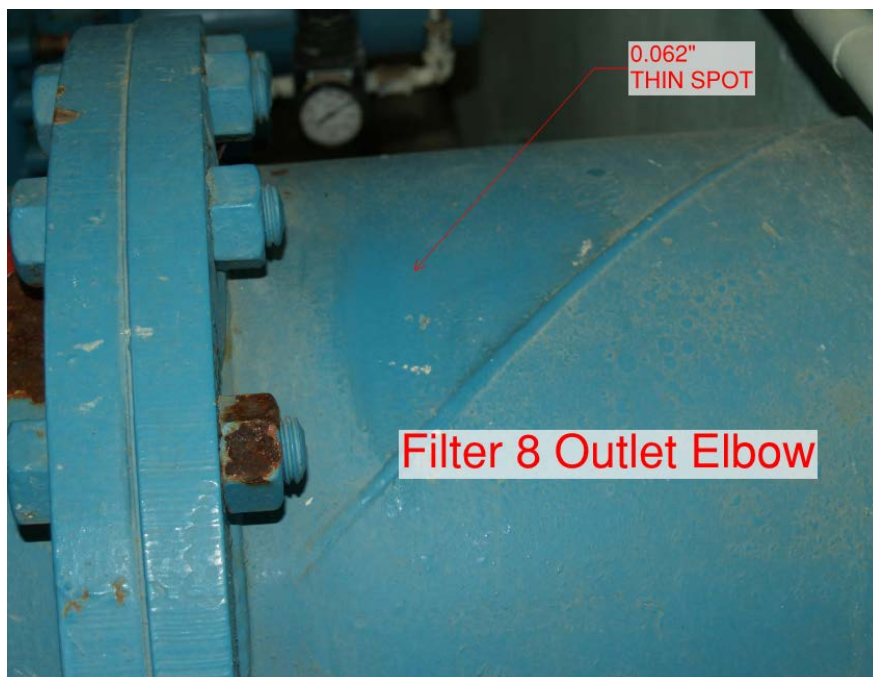
Figure 2-8B. Filter 8 Outlet Elbow with Measured Thin Spot Indicated
(Location with a measured thickness of less the 0.10 inches)

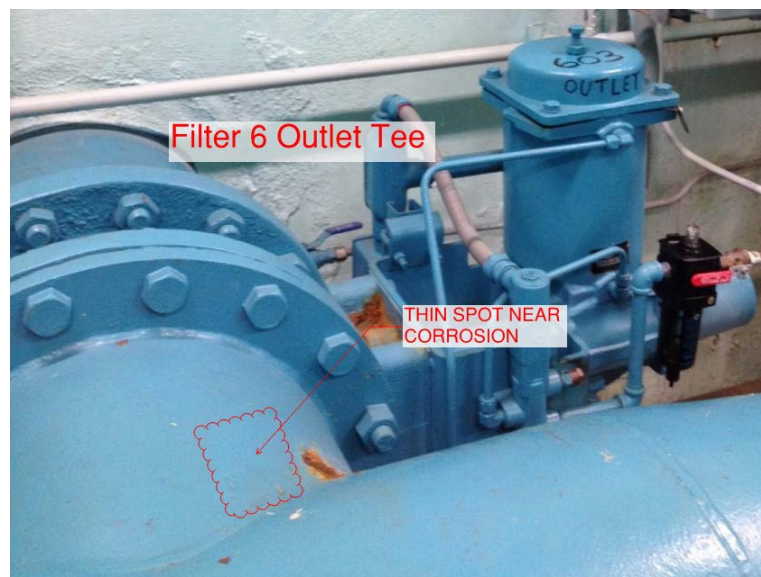
Figure 2-9. Filter 6 Outlet Tee

Figure 2-9 shows a severe thin spot near the exterior corrosion on the Filter 6 outlet tee.

Table 2-9. Field Measurement of Filter 6 Outlet Tee Thicknesses (inches)	
Top of Outlet Tee	
Top	0.100
	0.167
	0.071
	0.067
	0.071
	0.137

Portions of Filters 5 and 6 outlet piping showed distinct pipe wall thickness losses. These spots occurred at outlet elbows and tees near where we found external corrosion. The filter piping also appears to be 7-gauge or Schedule 10.

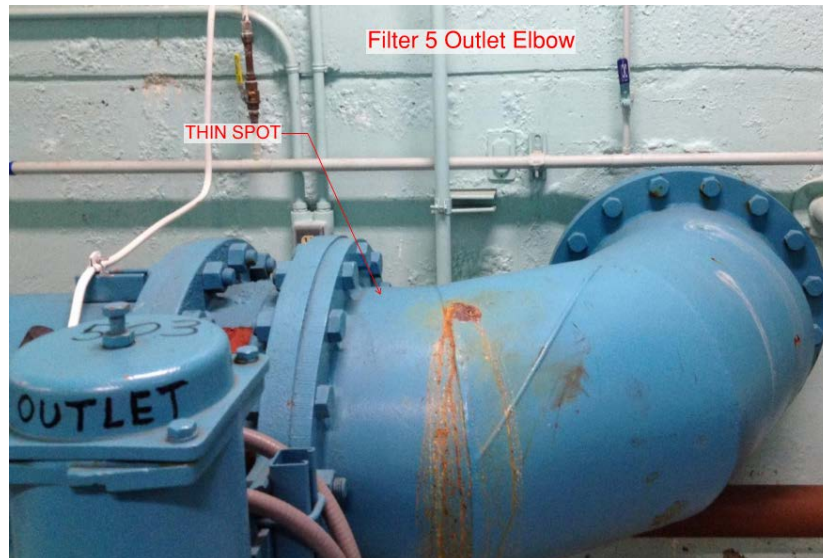
Figure 2-10. Filter 10 Outlet Elbow with Exterior Corrosion

Figure 2-10 shows the location of a thin area near some exterior corrosion along the Filter 5 outlet elbow.

Table 2-10. Field Measurement of Filter 5 Outlet Elbow Thicknesses (inches)				
Filter 5: Outlet Elbow Top Near Valve Around Corrosion				
Top	0.057	0.159	0.11	0.164
